FIRE SAFETY PERFORMANCE OF MOTOR VEHICLES IN CRASHES

Kennerly H. Digges¹
R. Rhoads Stephenson¹
Paul G. Bedewi²

¹Motor Vehicle Fire Research Institute (MVFRI)

Paper Number 422

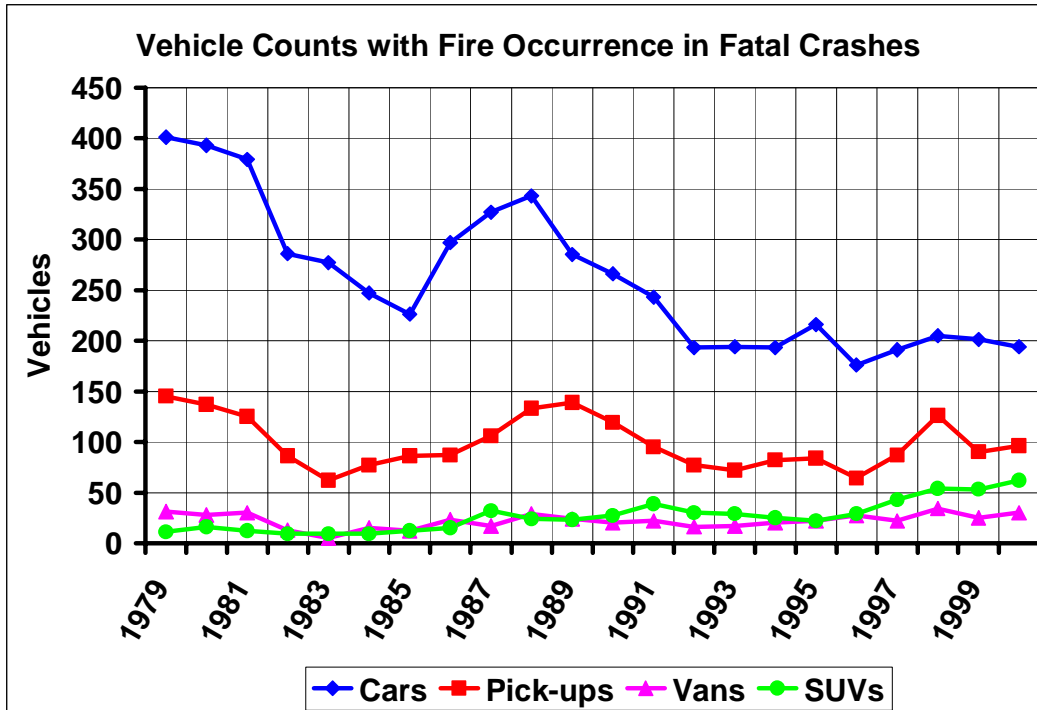
Figure 1. Frequency counts of vehicles involved in fatal crashes where a fire occurred in that particular vehicle (fatality did not necessarily occur in the vehicle with the fire). Data is from FARS 1979-2000, vehicle age is 0-4 years, and distributions are by vehicle type.

Figure 1 shows the fire occurrence for vehicles 0 to 4 years old at the time they were involved in fatal accidents. To be counted, a fire had to occur in the vehicle after the crash and a fatality had to occur in the crash. The fatality may or may not have been in that particular vehicle or caused by the fire. Figure 2 displays the same data adjusted for vehicle exposure. The exposure metric used in the figure is the number of registered vehicle years by vehicle class, given as million vehicle years or MVY.

This study looks at vehicles of age 0-4 years; therefore, FARS year 2000 includes models years 1996-2000. A significant occurrence took place during model year 1976 with the introduction of the FMVSS 301 standard for fuel system integrity. Based on data in these figures, FARS year 1981 would be the first year with all vehicles FMVSS 301 compliant.

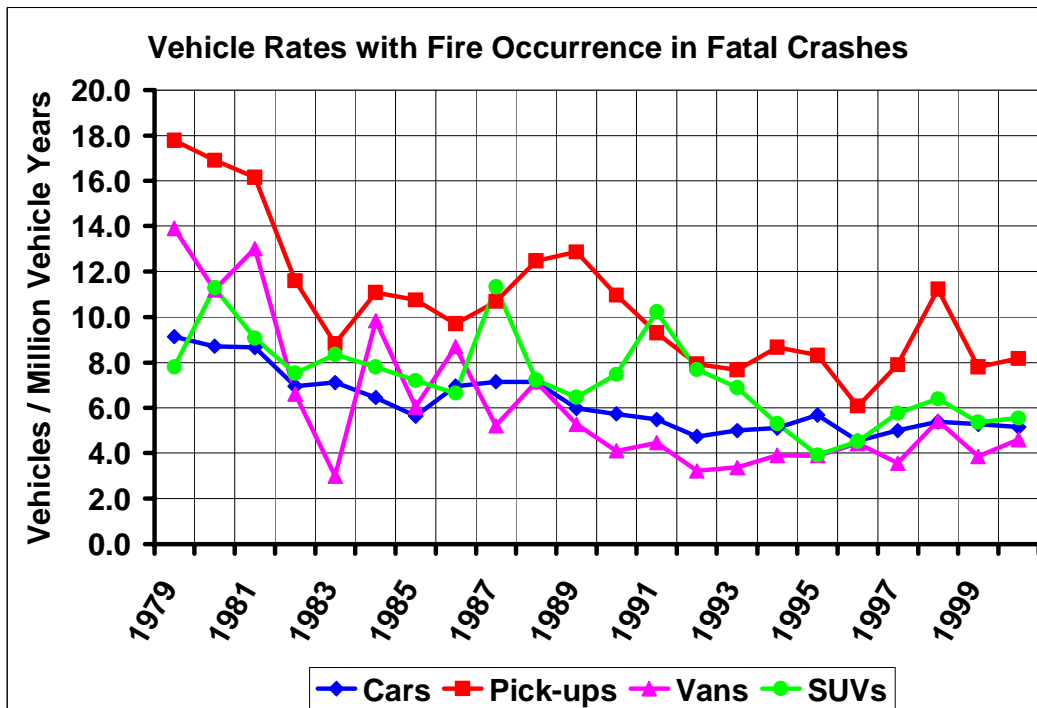
Figure 2. Rates per million vehicle registered years of vehicles involved in fatal crashes where a fire occurred in that particular vehicle (fatality did not necessarily occur in the vehicle with the fire). Data is from FARS 1979-2000, vehicle age is 0-4 years, and distributions are by vehicle type.

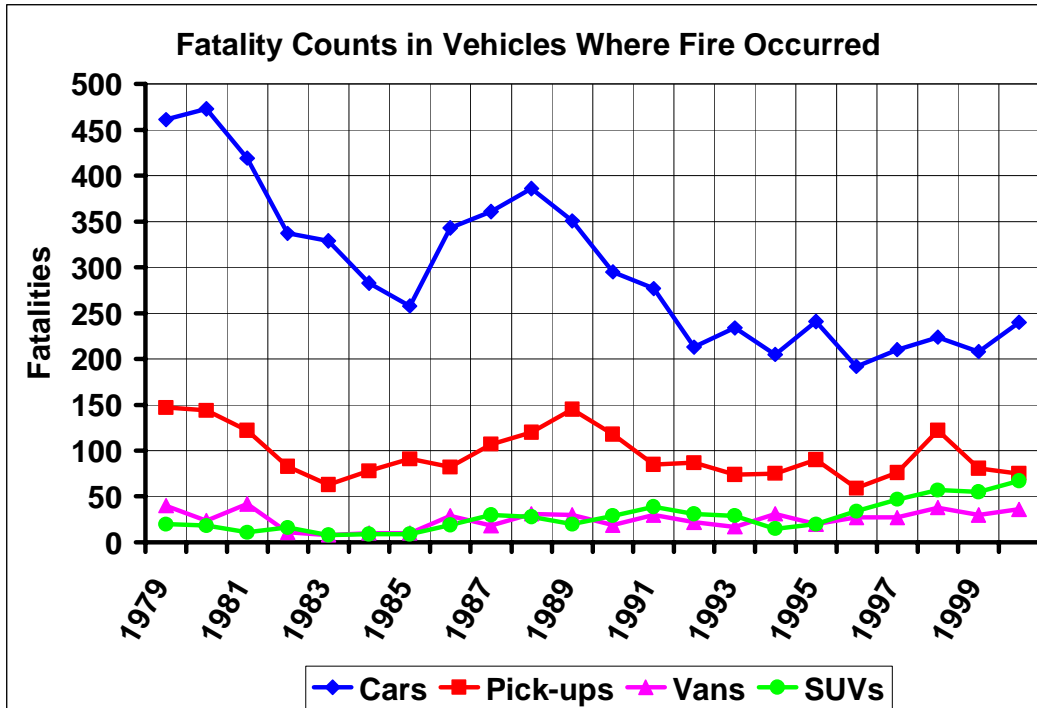
Figure 3. Fatality counts in vehicles where there was the occurrence of a fire/explosion (fatality is not necessarily attributed to the fire event). Data is from FARS 1979-2000, vehicle age is 0-4 years, and distributions are by vehicle type.

Figures 3 and 4 provide the fatality counts and rates for fatal crashes in which the fatality occurred in the vehicle where there was a fire. In these figures the fatality was not necessarily attributed to the fire event. Figures 5 and 6 relate the number and rate of fatalities to the fire event. In these figures, the fire event has been coded as the most harmful event, indicating it was the cause of the fatality. Often times it may be difficult to discern the cause of the fatality in these crashes (biomechanical trauma vs. fire trauma). This distinction was not investigated and the coding was taken directly from FARS. Previous studies have attempted to investigate the uncertainty and difficulty in coding fire as the most harmful event [Davies 2002].

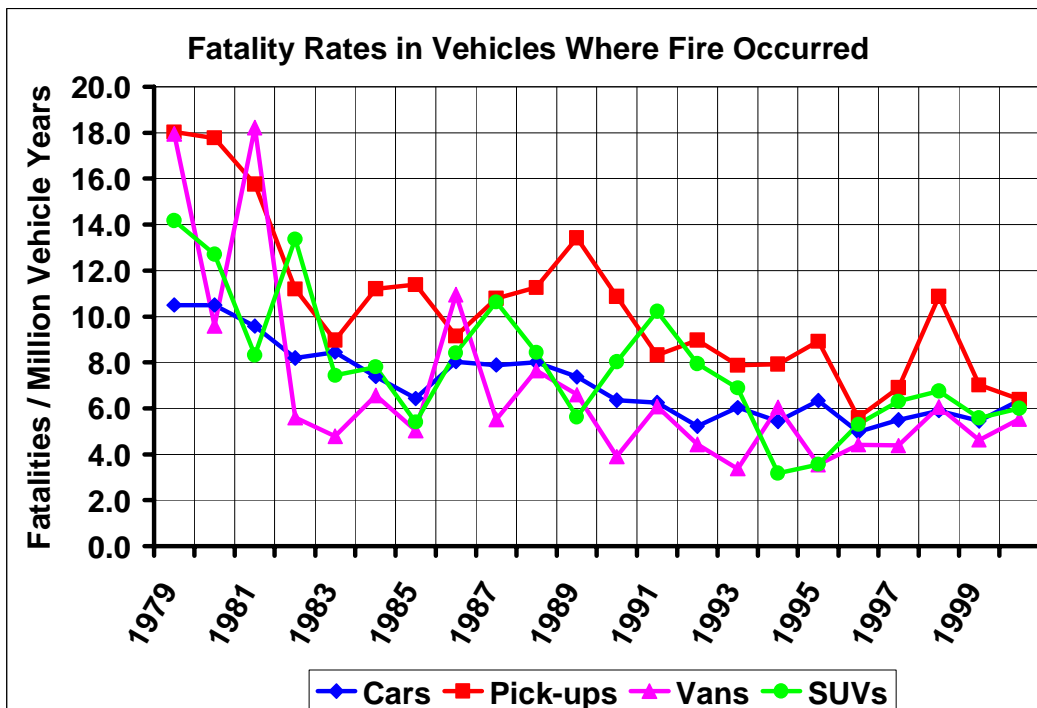
Figure 4. Fatality rates per million vehicle registered years in vehicles where there was the occurrence of a fire/explosion (fatality is not necessarily attributed to the fire event). Data is from FARS 1979-2000, vehicle age is 0-4 years, and distributions are by vehicle type.

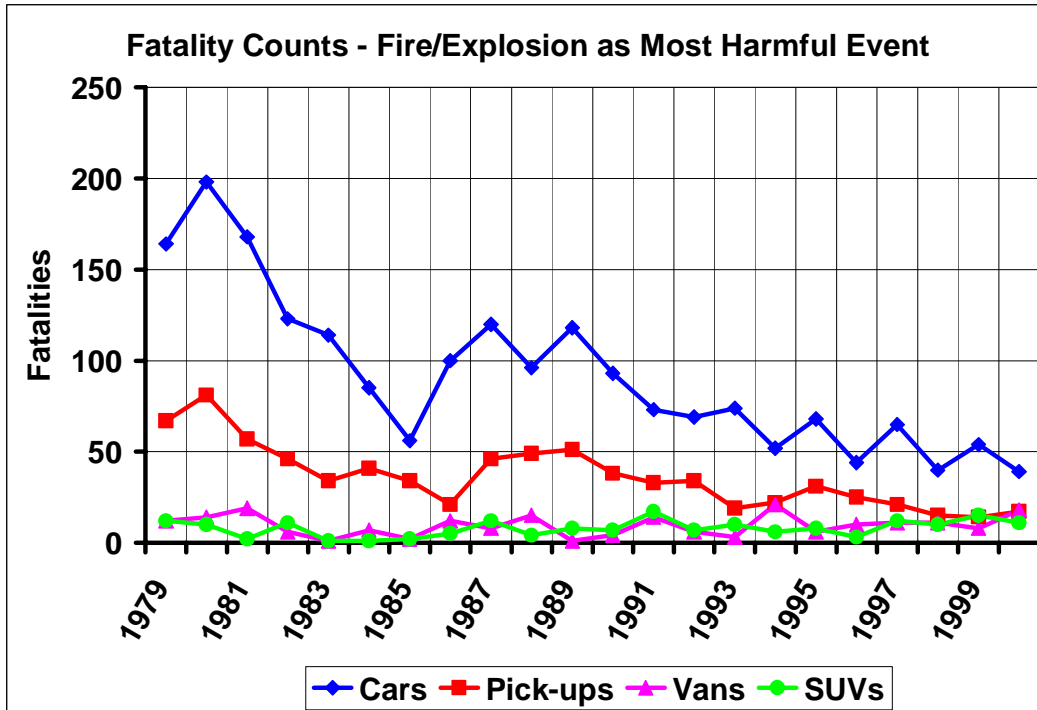
Figure 5. Fatality counts in vehicles where there was the occurrence of a fire/explosion and the fire event has been coded as the most harmful event (i.e. cause of death). Data is from FARS 1979-2000, vehicle age is 0-4 years, and distributions are by vehicle type.

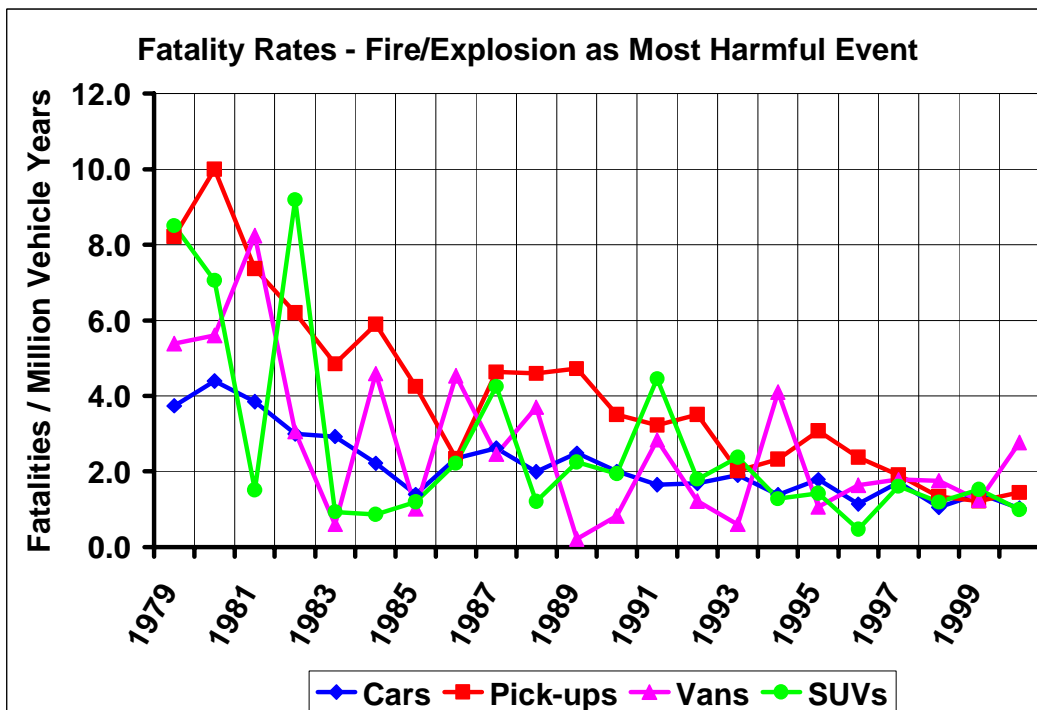
Figure 6. Fatality rates per million vehicle registered years in vehicles where there was the occurrence of a fire/explosion and the fire event has been coded as the most harmful event (i.e. cause of death). Data is from FARS 1979-2000, vehicle age is 0-4 years, and distributions are by vehicle type.

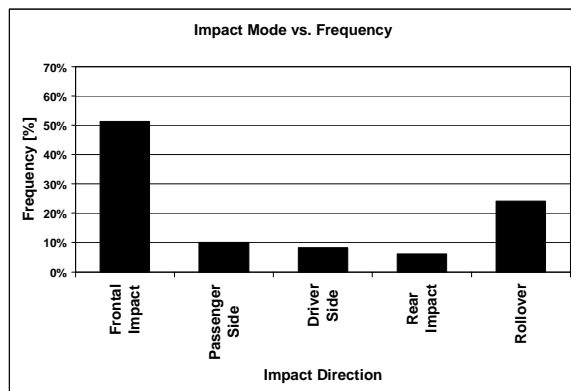
Figure 7. Distribution of fire events by impact direction.

When looking at impact direction, the cases were divided into categories of impact that would be associated with the fire event. For example, if a frontal impact occurred with another vehicle followed by a side impact to a tree, and the tree impact was the source of a ruptured fuel tank, this would be classified as a side impact for this study. Based on this criterion, frontal impacts accounted for 117 cases (51.3%), side impacts 42 cases (18.4%), rear impacts 14 cases (6.1%), and rollovers 55 cases (24.1%). These results can be seen in Figure 7. It is interesting to note that rear impacts had the lowest frequency of fire events.

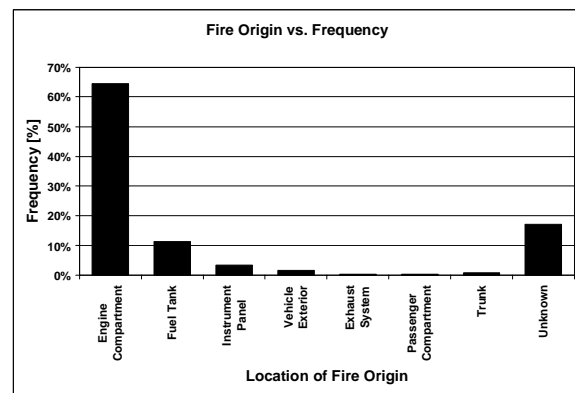
Figure 8. Distribution of fire origin/location.

The location and/or origin of the fire can provide useful information to researchers looking to further improve vehicle design and prevent fire events. The distribution of the fire origin within these NASS/CDS cases is shown in Figure 8. Of particular interest is that a large majority of fires (147 cases – 64.5%) initiated inside the engine compartment. In 26 cases (11.4%) it could be definitively determined that the fuel tank was the source of the fire. Often times it is difficult or impossible to determine the fire origin. This typically occurs in cases in which the vehicle was completely engulfed. There were 39 cases (17.1%) with unknown fire origins. This distribution is similar to previous studies and warrants further investigation into specific sources of fire initiation within the engine compartment.

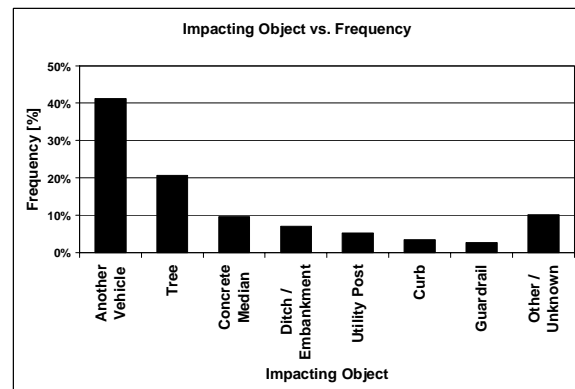
Figure 9. Distribution of fire events by impacting object.

This initial review of the data also identified the distribution of impacting objects for fire events (Figure 9). In 94 cases (41.2%) another vehicle was

the impacting object that was associated with the fire event. Although Figure 9 shows a more detailed breakdown of the impacting object, it can be seen that in 111 cases (48.7%) a fixed roadside object was the source of impact and the fire event. In a majority of these cases the fixed object is narrow and results in significant penetration at concentrated locations along the vehicle. Though further investigation is warranted and ongoing, impacts with fixed narrow objects account for a larger portion of the fuel tank related fires.

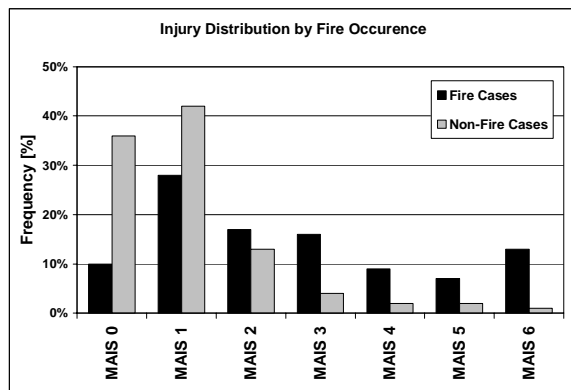
Figure 10. Injury distribution by MAIS for fire and non-fire cases.

Results show some interesting initial findings. Fire events tend to have a significantly greater percentage of MAIS 3+ associated injuries. While fire events are relatively infrequent, their occurrence tends to have greater associated harm. Further investigation into the injuries within each case is ongoing.

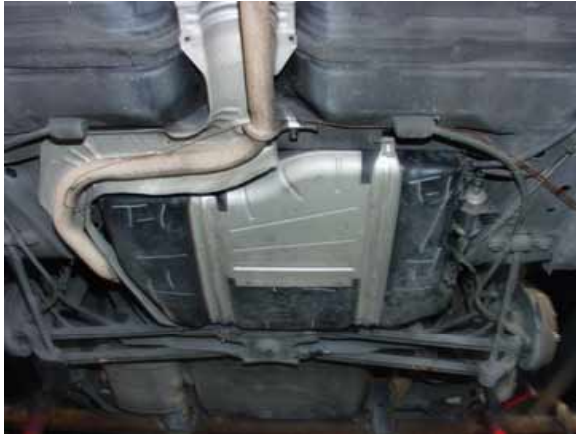
Figure 11. "Pancake" shaped tank pre-test.

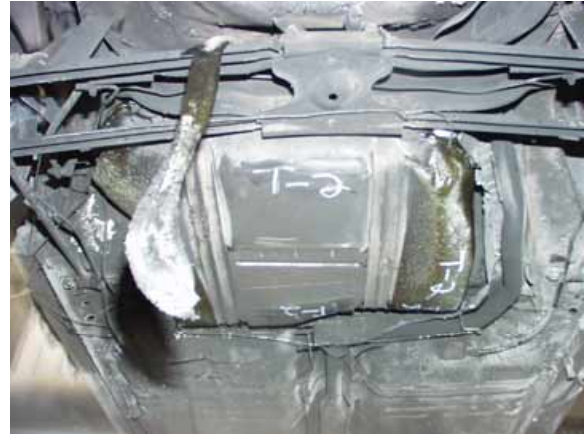
Figure 14. "Pancake" tank after fire test.

Other observations made from the tests included the location and size of the initial leak that occurred before the fire was extinguished. The two pancake tanks leaked at the same place – the bottom left rear corner. In both cases, the leaks were very small. The two square tanks both leaked in locations that were associated with loading by the mounting strap. Both tanks also leaked or were severely weakened at the front right top corner due to sagging of the tank. The rate of leakage from the square tank was greater than for the pancake tank. The two long tanks both leaked due to sagging of the front part of the tank that overhung the mounting straps. The leakage occurred at the front of the tank or at the straps. The rate of leakage was greater than the square tank. The post test deformation of the “pancake” tank, the “long” tank, and the “square” tank are shown in Figures 14 through 16.

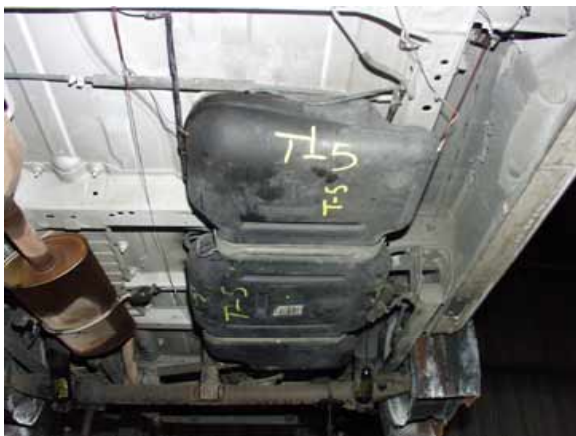
Figure 12. "Long" shaped tank pre-test.

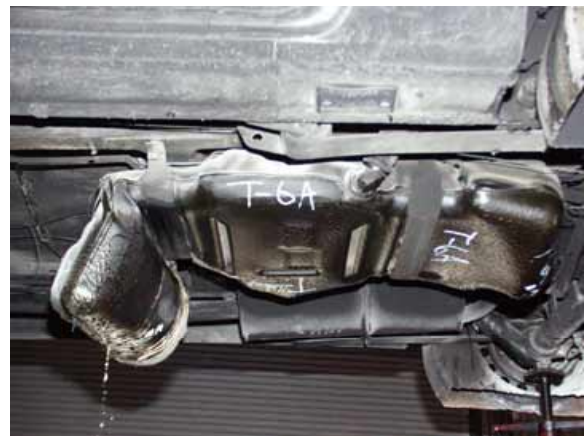
Figure 15. "Long" tank after fire test.

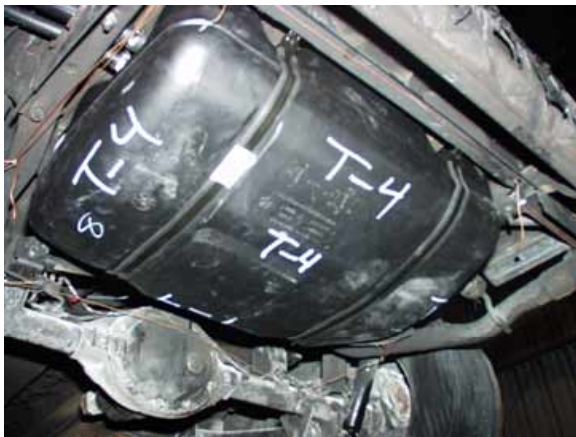
Figure 13. "Square" shaped tank pre-test.

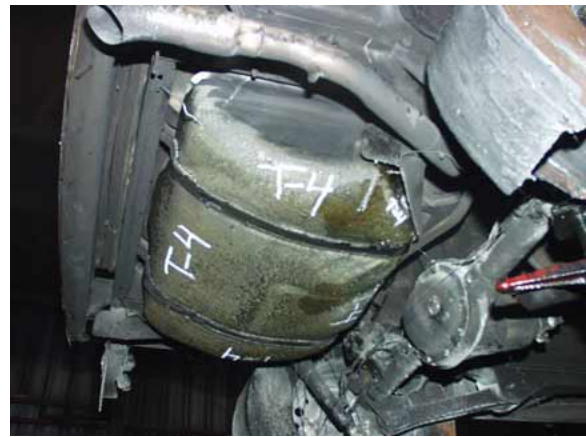
Figure 16. "Square" tank after fire test.

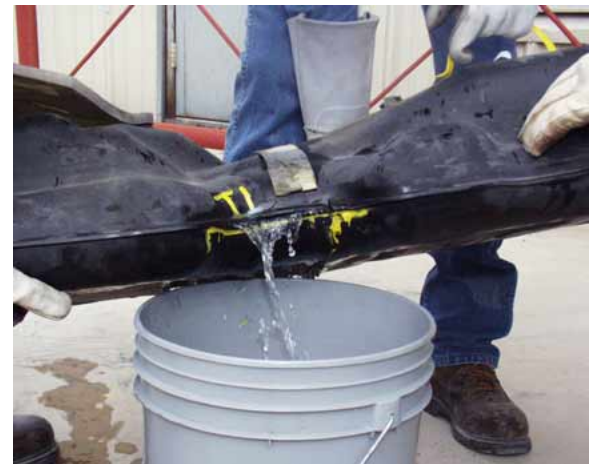
Figure 17. Seasoned “Long” Tank Post Drop Test

The results of the 30 ft drop tests are shown in Table 4. All of the new tanks and the seasoned pancake tank passed the test. However, both of the other seasoned tanks ruptured at the pinch-off separation. A typical breach of the tank is shown in Figure 17.
